### **Contributing Causes and Lessons Learned from NREL's Recent Laser Accident**

Deana Luke, National Renewable Energy Lab Health & Safety Manager & LSO September 27, 2016

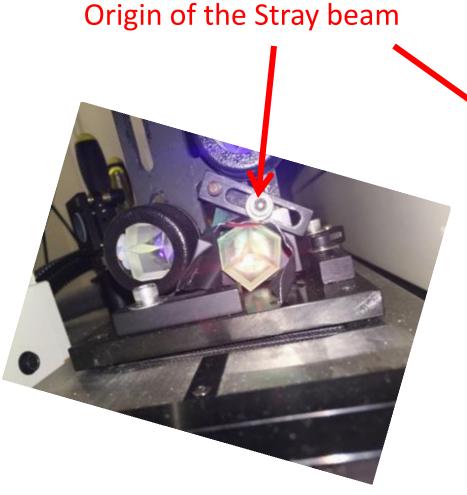
Front view

### **Retro-Reflector Cube Corners**

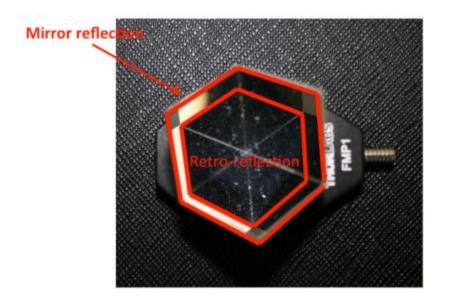
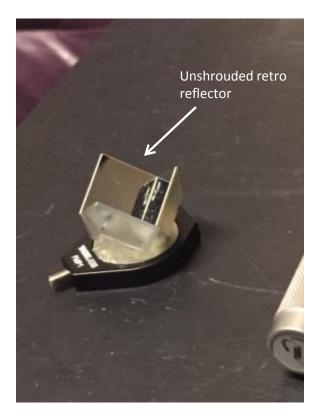
### **Unshielded Retro-Reflector Cube Corners**

- An unshielded retro-reflector was used in beam path
- Beam misaligned on outer edge of retro-reflector
- Specular reflection misdirected toward worker

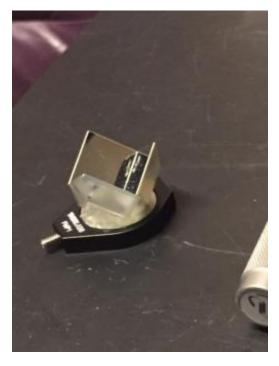
### **Contributing Cause - Retroreflector**

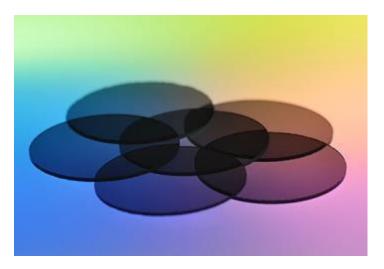
- Attention given to wrong issues
  - Engineering controls not properly applied
    - Improper placement of neutral density filter
    - Insufficient beam shielding

Place neutral density filters as close to output as possible
