### **Contributing Causes and Lessons Learned from NREL's Recent Laser Accident**

Deana Luke, National Renewable Energy Lab Health & Safety Manager & LSO September 27, 2016

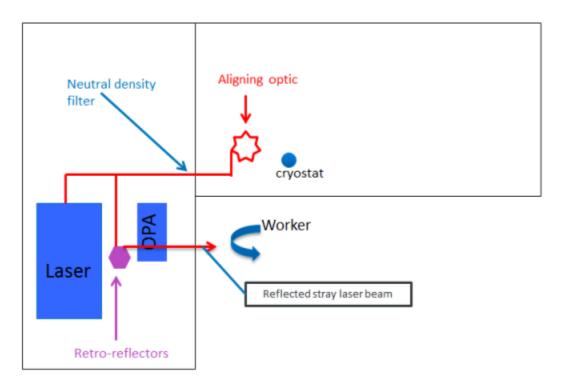
- New NREL postdoctoral worker performing high precision alignment of optical component on Class 4 laser system
- Worker lowered eyewear to view beam with naked eye instead of using IR viewer or viewing cards.
- Received strike to eye from stray beam reflected from optical component

- Affected system locked out from use
- Safety Pause conducted for all laser users and their managers to overview incident and share initial lessons learned
- Post-doc restricted from working with Class 3B and 4 lasers during investigation
- Lab-wide Extent of Condition conducted to ID locations where unshrouded retro-reflectors were in use
  - Removed 2 unshrouded retro-reflectors from service
  - Removed 4 additional retro-reflectors which were in storage
- Immediately began investigation and causal analysis
